CALIBRATION, TEST, FIELD OPERATION AND
REFURBISHMENT OF BALLOON BORNE
RADIOMETER

Arthur G. DeBell

Rockwell International Corporation

FINAL REPORT

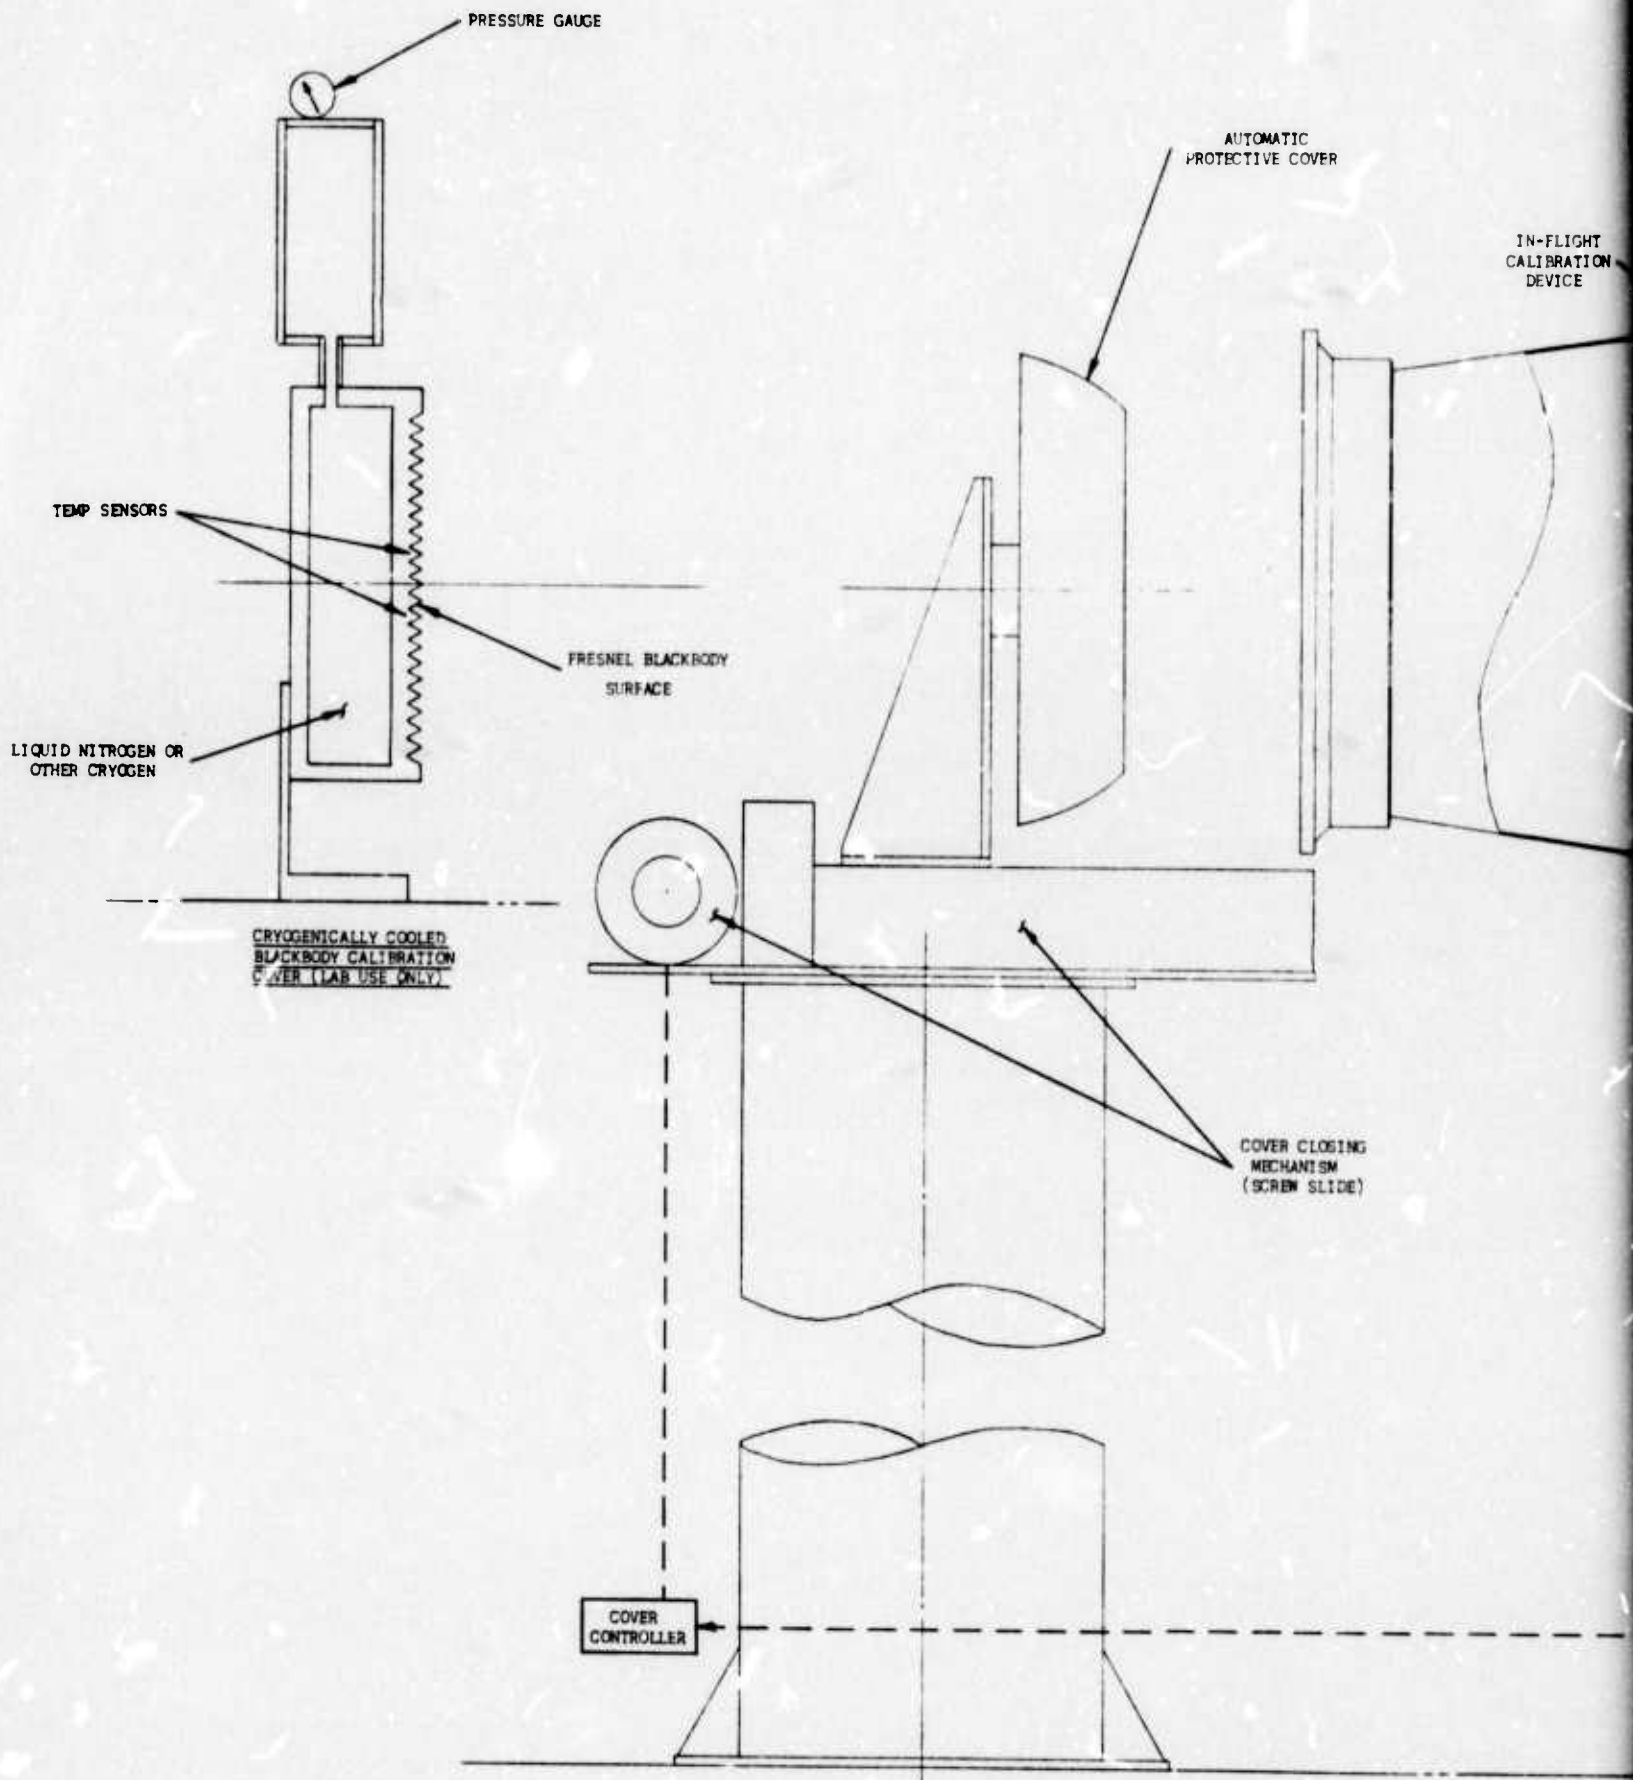
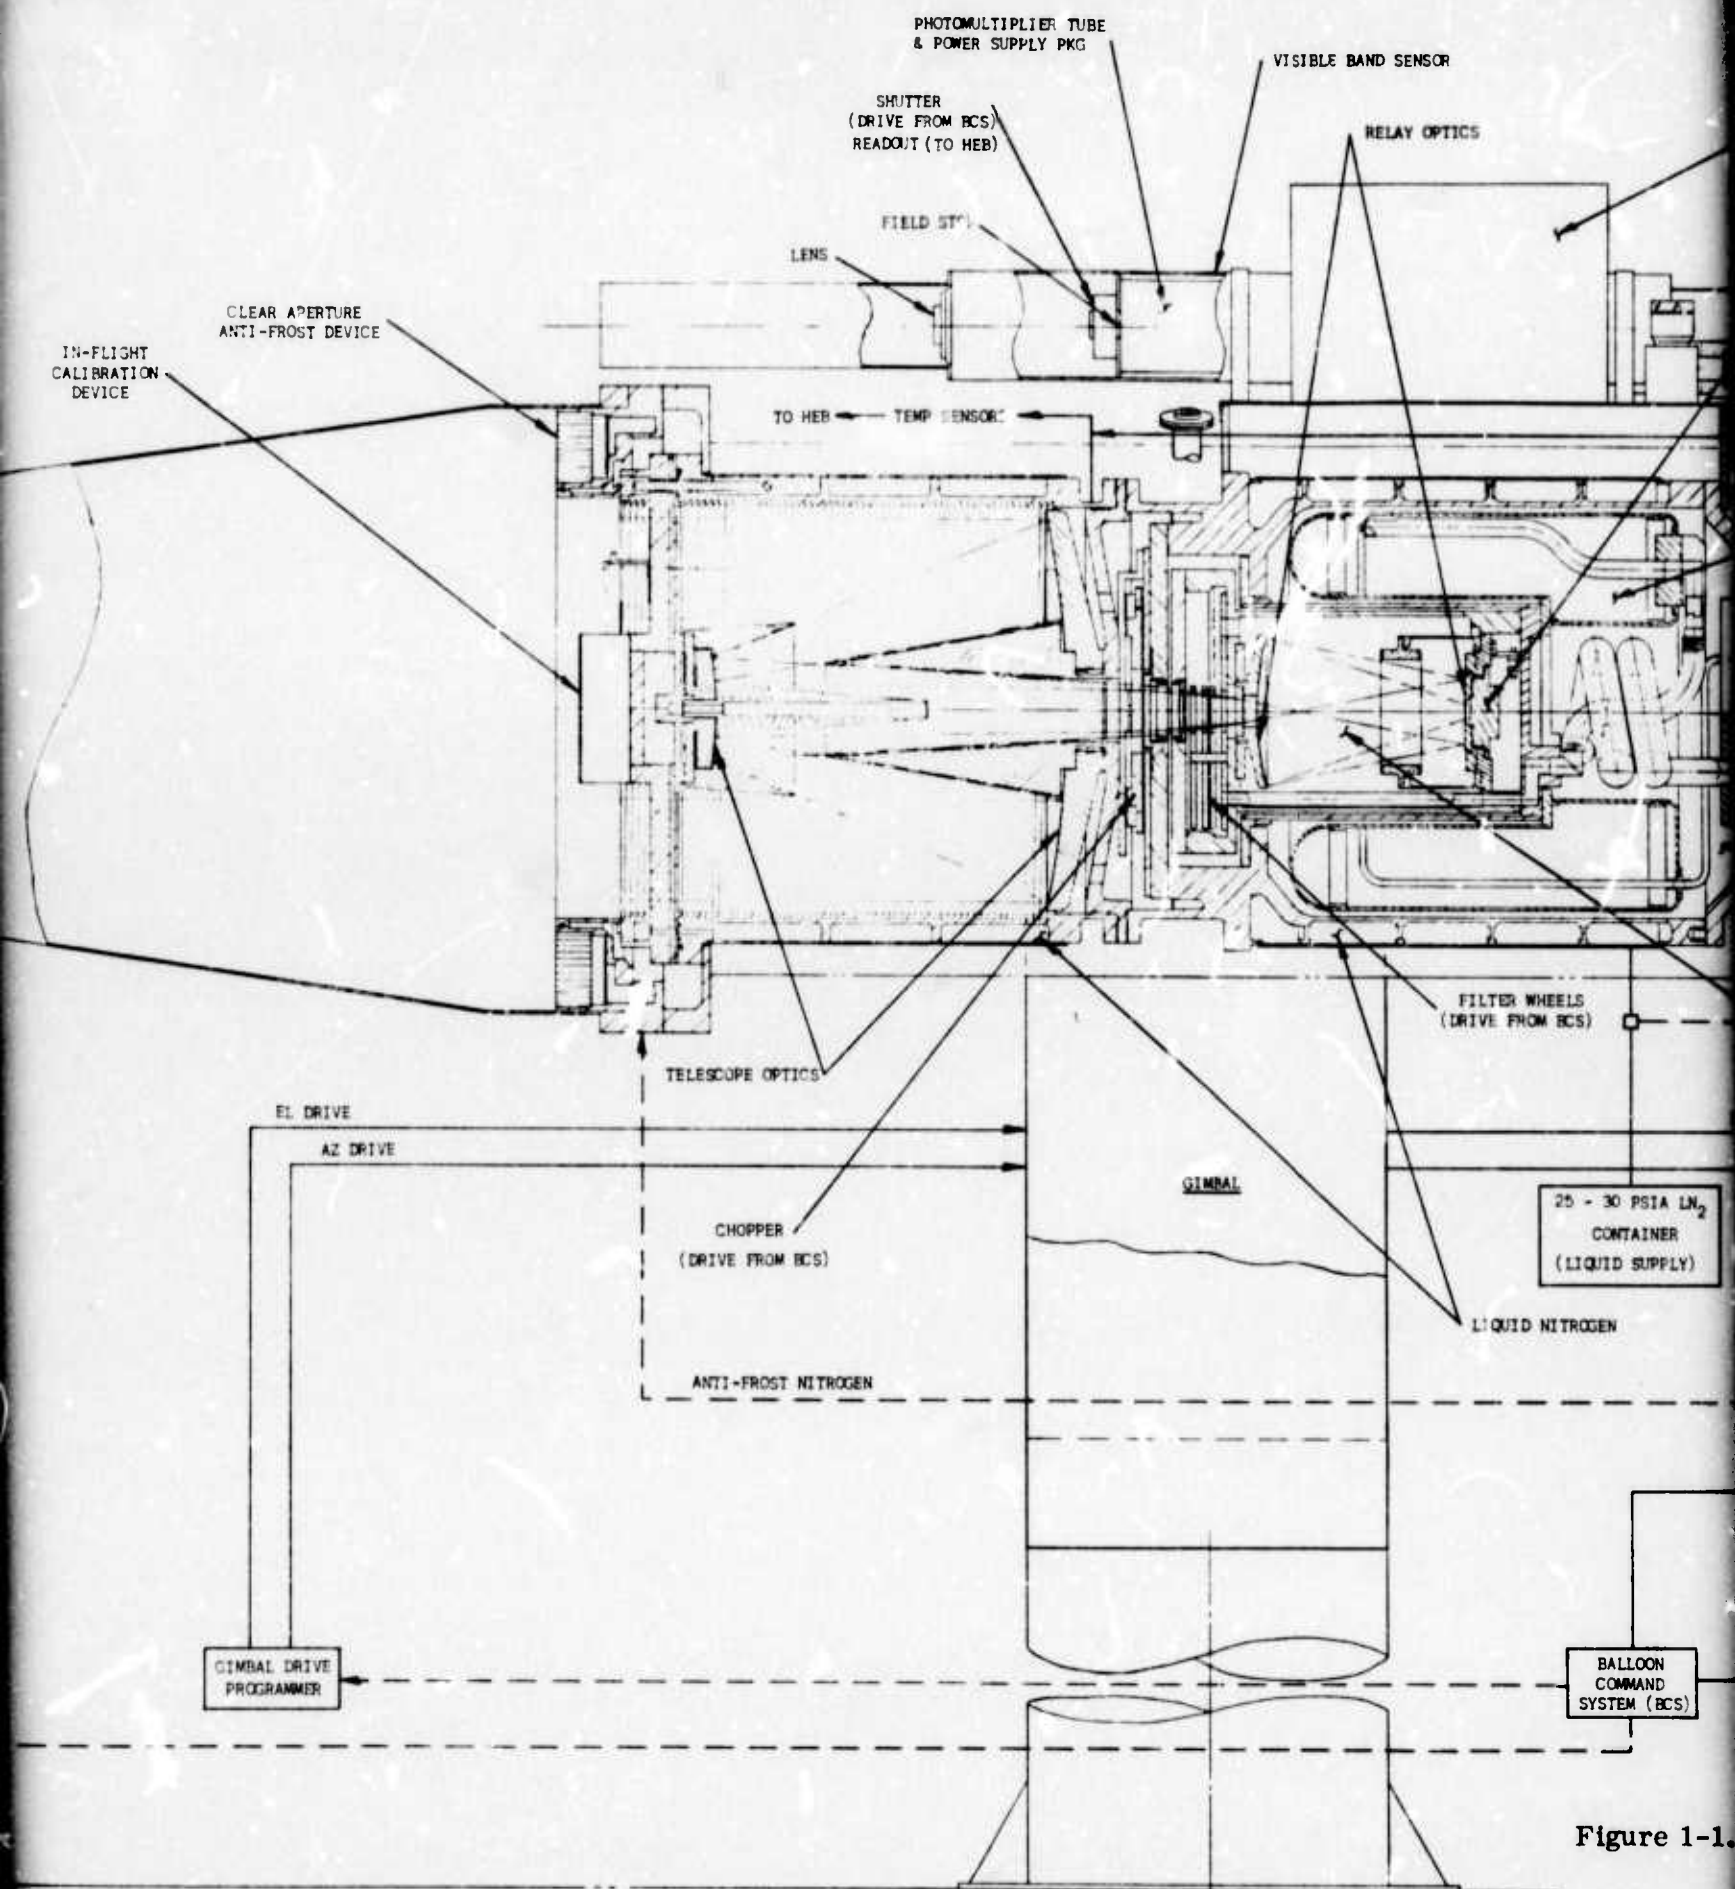
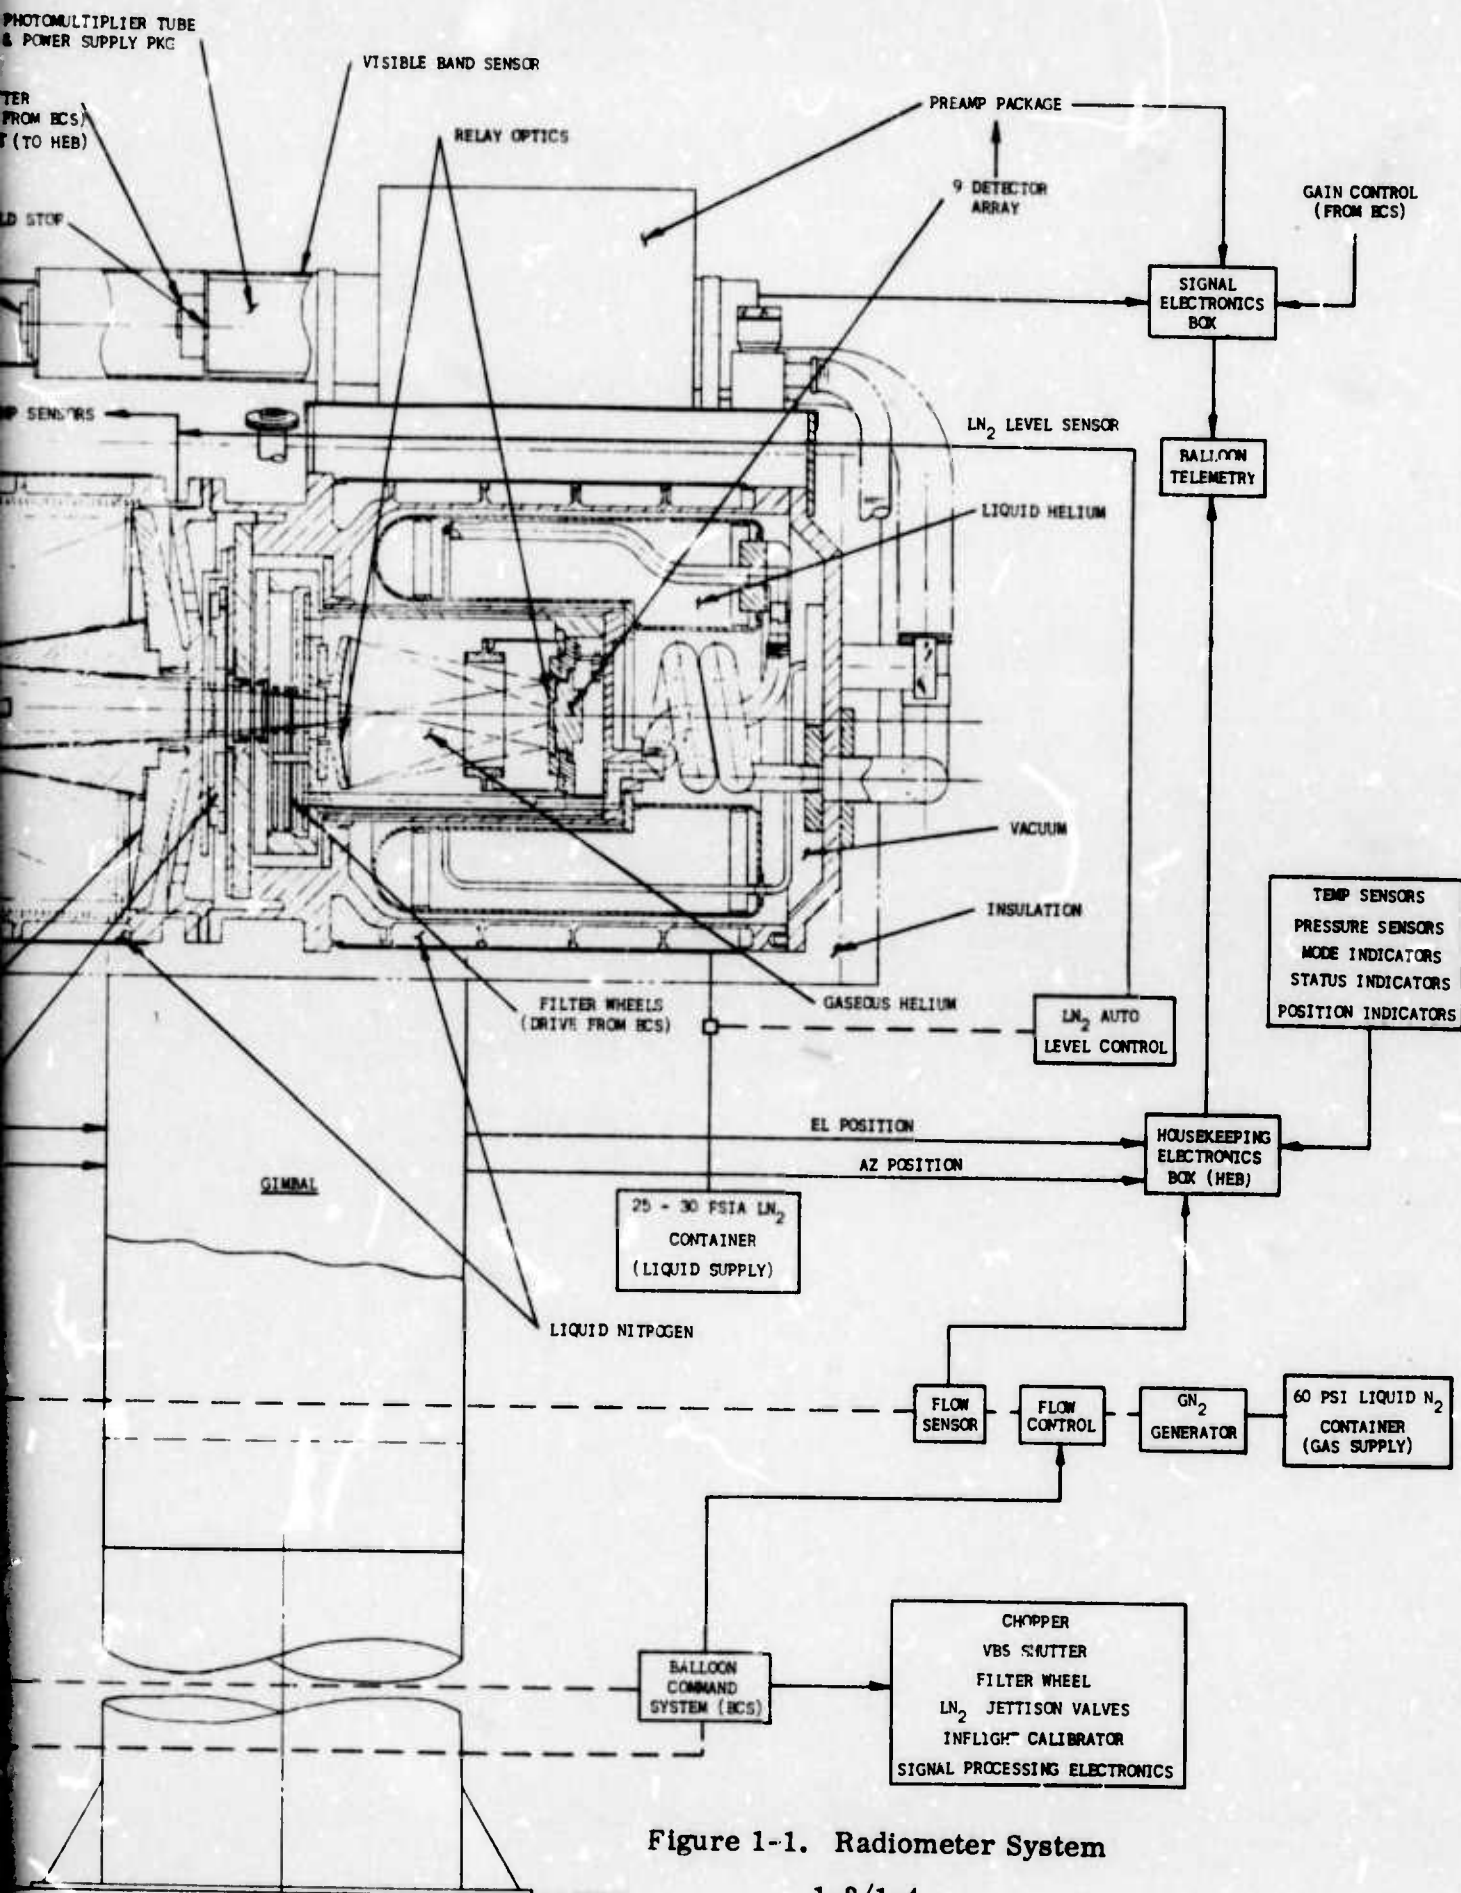
Figure 1-1. Radiometer System

A unique feature of the radiometer is the ability to remotely operate its many controls by means of commands radioed from the ground. Figure 1-1 is a schematic of the radiometer system.

The light gathering system of the radiometer is a well baffled Cassegrain telescope with a 10 in. diameter primary mirror. As the telescope's converging beam of radiation approaches its focus it passes through the plane of the rotary chopper, which upon command is capable of interrupting the beam at 200 Hz, allowing the beam to pass through uninterrupted, or blocking the beam. After passing through the Intran-VI window and the Intran-VI field lens which seal the vacuum space, the beam passes into the helium gas cooled reimaging cavity. The beam comes to focus on a compound field stop which contains nine individual openings each twice as large as the corresponding detector mask.

The Cassegrain telescope is kept at 77 K by a liquid nitrogen jacket and the reimaging optics are kept at approximately 10 K by boil-off gas from the liquid helium tank. Frost is prevented from forming on the cooled telescope optics by means of a clear aperture antifrost device which extends out in front of the telescope. The antifrost device is capable of protecting the system, when utilizing the gaseous nitrogen produced from an on-board gas generator, at altitudes as low as 35,000 ft. The system performs absolute radiometry in the band from 3 to 25 microns.

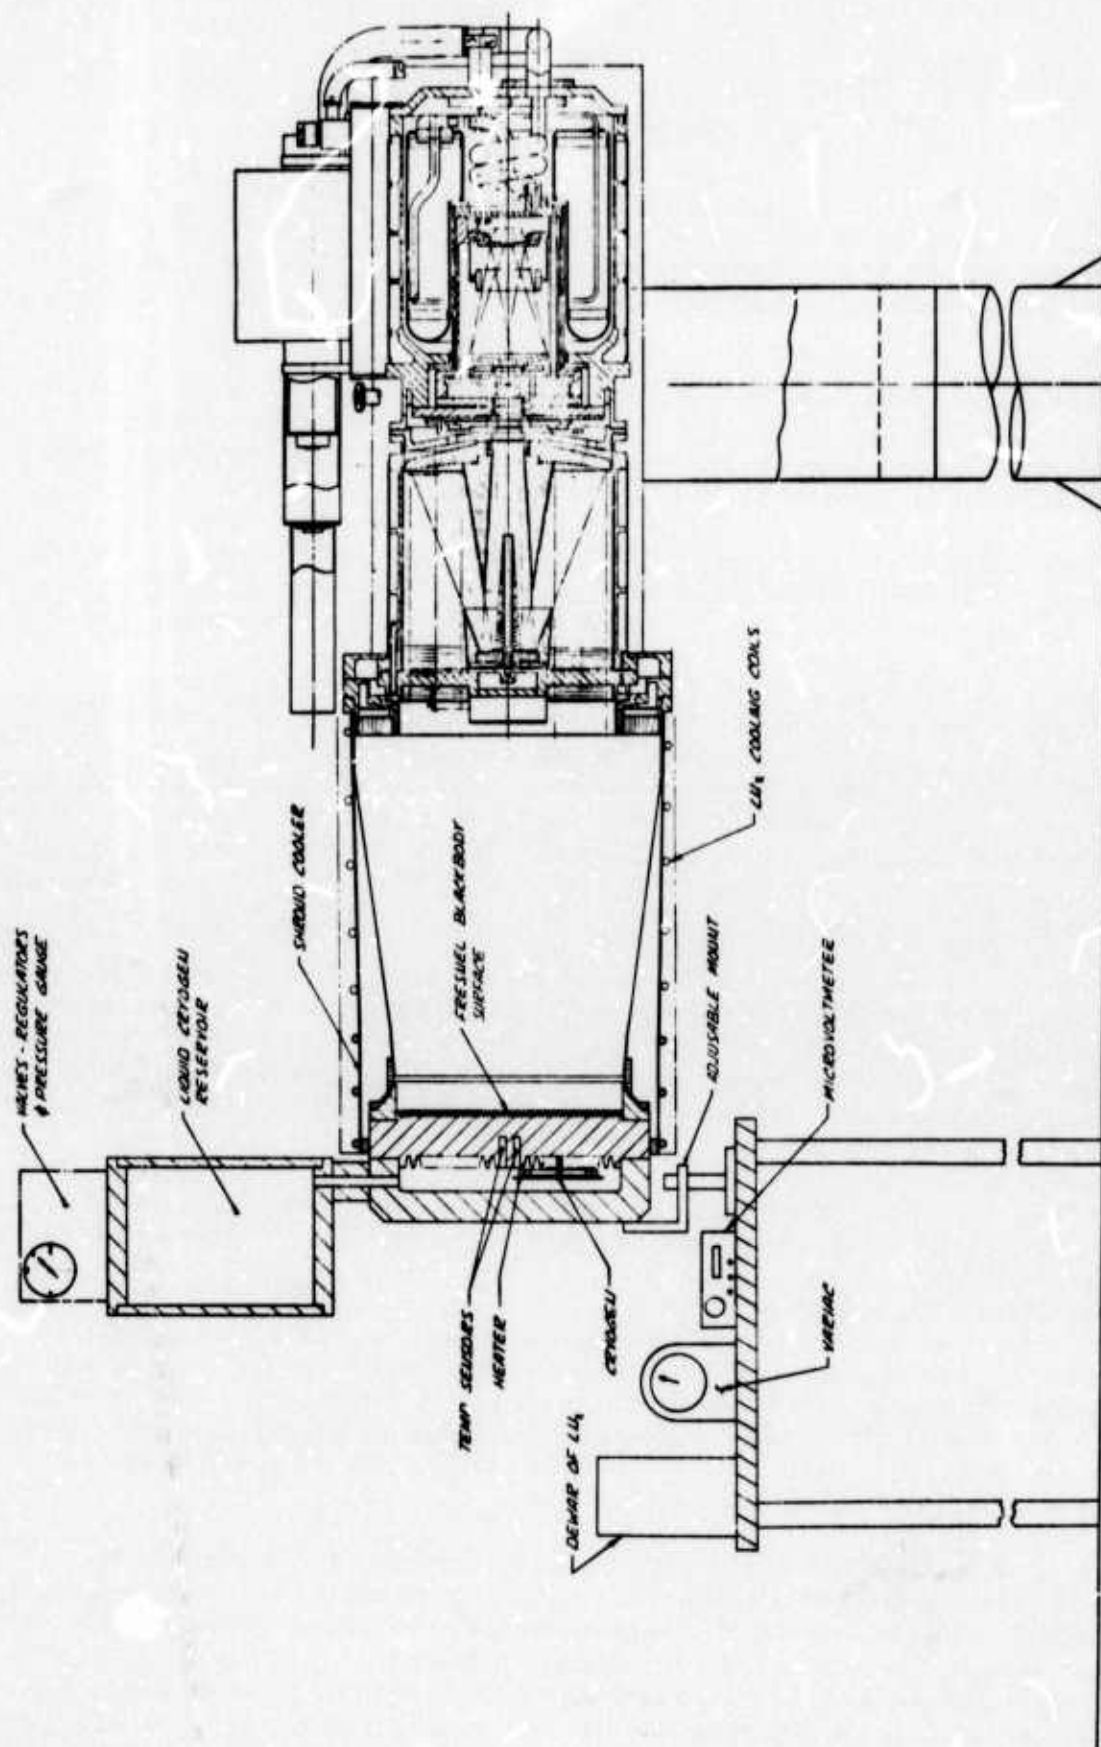
Figure 2-1. Radiometric Calibration Set-Up

Figure 2-1 illustrates schematically the laboratory set up which was used to accomplish the radiometric calibration of the instrument. The laboratory calibrator which is the key piece of equipment used in the calibration is unique and requires description.

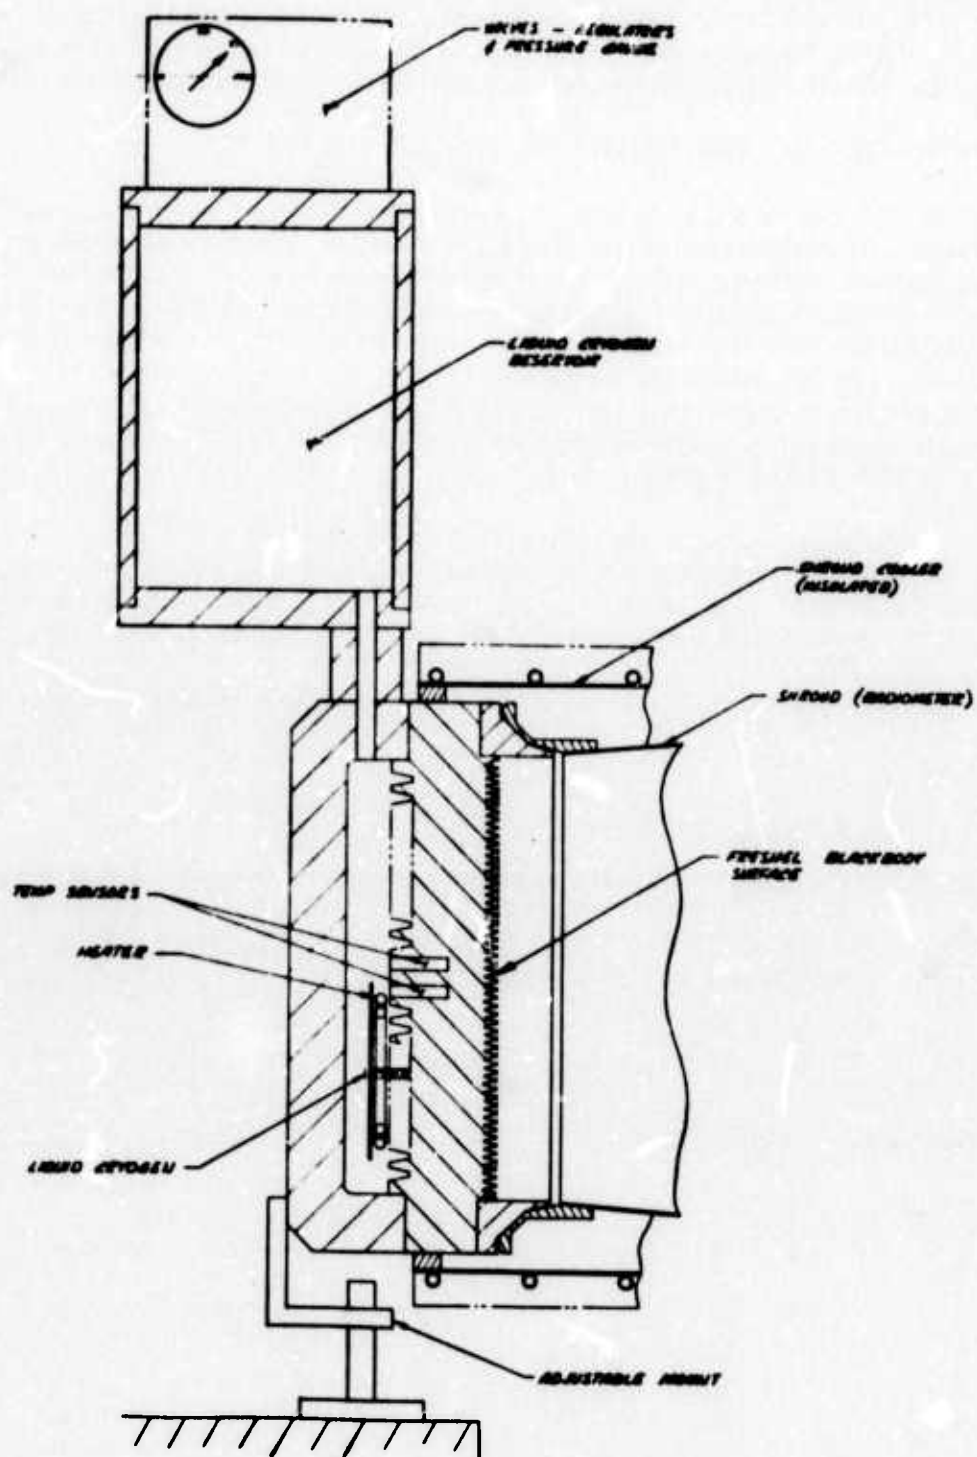
Figure 2-2. Laboratory Calibrator

The laboratory calibrator is a variable temperature blackbody source which is used for the pre-flight calibration of the infrared sensor. The device consists essentially of an insulated cryogenic pressure vessel in which the blackbody source, a circular, grooved plate, forms part of the wall. The heavy walled vessel can be operated at any pressure up to approximately 300 psi. The temperature can be varied almost continuously from under 77 K to 300 K. Large incremental changes of temperature previously had been achieved by using different cryogens. For a given cryogenic liquid, controlled, continuous changes of temperature are created at present by varying the pressure within the dewar.

Figure 2-2 is a schematic drawing which shows the calibration device as it appears when attached to the shroud of the infrared sensor. The basic parts are the pressure vessel, calibration source plate, valves and pressure regulators, temperature sensors, and mounting devices. The outside of the calibration source plate is grooved with concentric circular grooves, and then sandblasted and black anodized in order to provide a high emissivity.

Concentric circular grooves are also machined on the inside of the plate in order to increase the heat transfer between the cryogen and plate. Mounted on the top of the dewar are a fill valve, vent valve, multi-pin electrical feed-through connector, burst disk, pressure relief valve, and pressure gauge. The temperature is monitored at a number of points within the source plate by copper constantan thermocouples. The sensor output leads are connected to the multi-pin electrical connector. Rigid attachment of the calibration device to the sensor is accomplished by clamps (not shown) which hold the sensor shroud against the mounting ring. The bottom mount supports the calibration device on a table. The pressure vessel is covered with Armaflex insulating material.

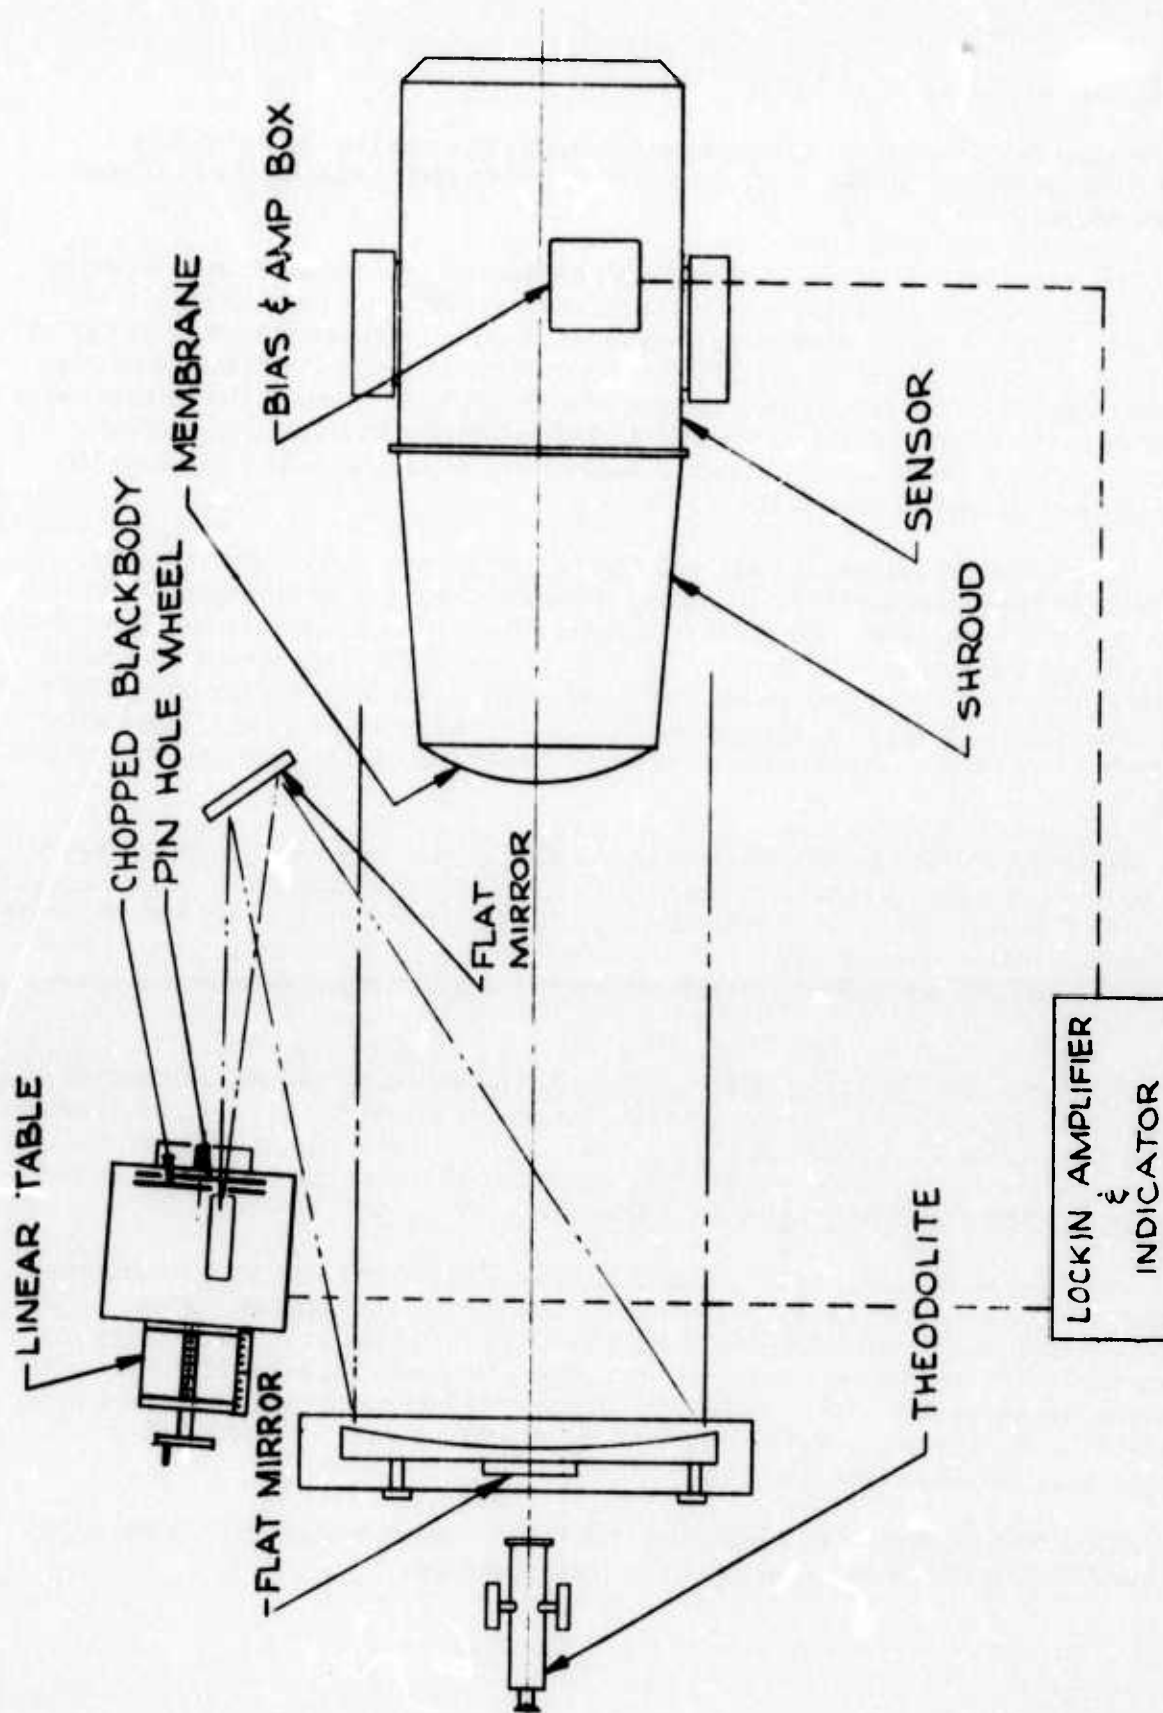
Figure 2-3. Focus and Field of View Arrangement

The instrument is set on its gimbals in the laboratory, its antifrost shroud is in place and a 0.005 mm. mylar membrane is installed to cover the aperture of the antifrost device. A 16 in. diameter, long focal length off-axis collimating mirror in a delicately adjustable mount is set up to send a collimated beam of infrared radiation into the instrument. A small plane mirror is attached to the back of the collimator so that it moves in angle with the collimator as the collimator is adjusted. A Wild theodolite is used as an angle-measuring autocollimator to accurately measure the small angular displacements of the collimating mirror.

The focus of the radiometer is brought to its desired position by changing the thickness of the spacer between the secondary mirror and its support. It was found necessary to increase the thickness of the spacer by 0.012 in. in order to bring the instrument to its best focus. A new spacer lapped to parallelism and of the required thickness was used rather than a stack up of shims to minimize the disturbance to the alignment of the secondary and to maximize its thermal contact with the liquid nitrogen chamber in its support.

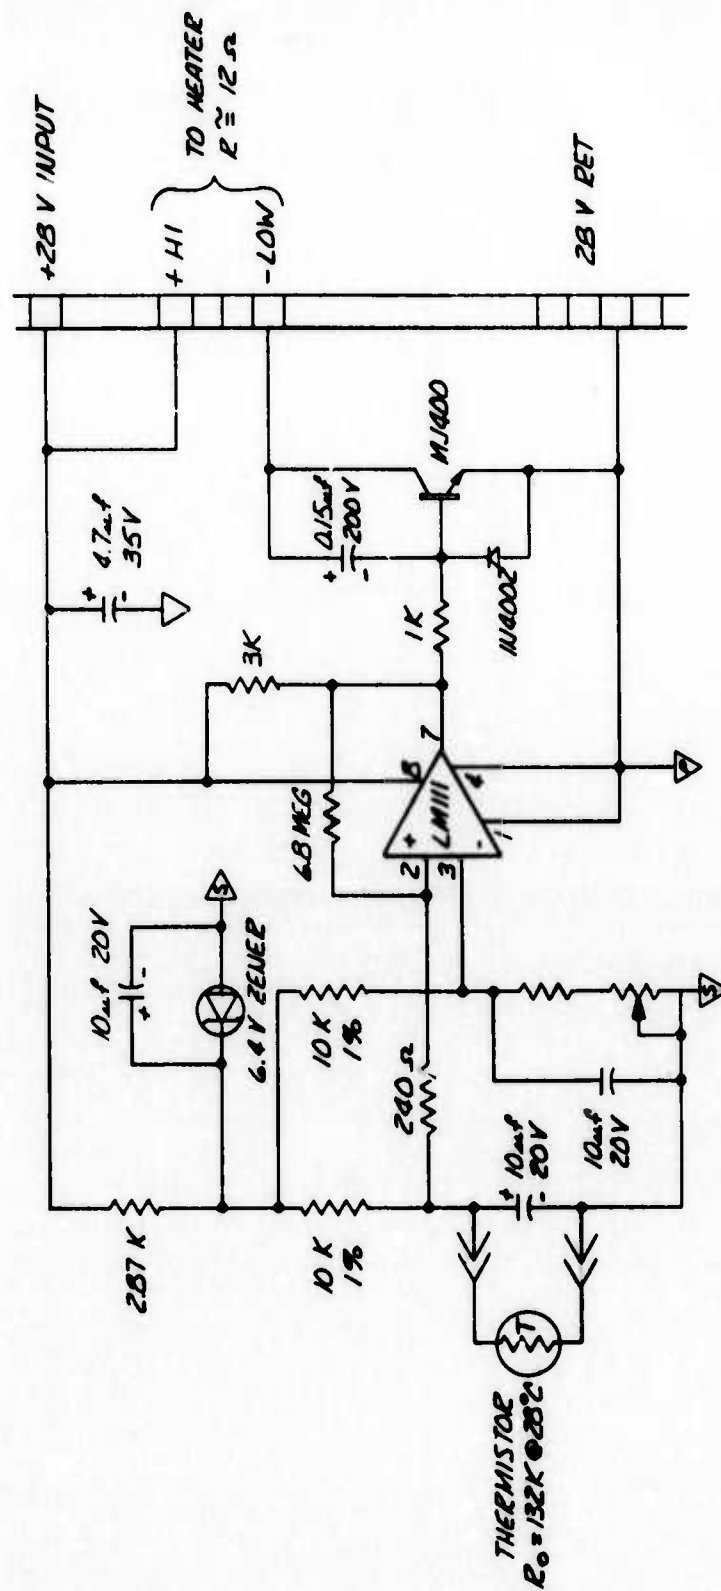
Figure 12-2. Input Electronics Temperature Control Circuit

During the course of the field work with the instrument it was found desirable to make modifications to the equipment to improve its operating performance. These modifications are documented in this report as revisions to the drawings which were originally included in the Balloon-Borne Cryogenically Cooled Filter Radiometer Research and Development Information Report No. C72-132/401. In this report they are designated with the usual figure notation for this report followed by a number in parenthesis which refers back to their original figure number in C72-132/401, i.e., Figure 12-14 (7-10) Schematic-Output Electronics Board 2002. An additional circuit was added to the instrument during this program. This was done in order to provide a better temperature control for the input electronics cannister than could be provided by a thermostat. This circuit is documented as Figure 12-2 Input Electronics Temperature Control Circuit.

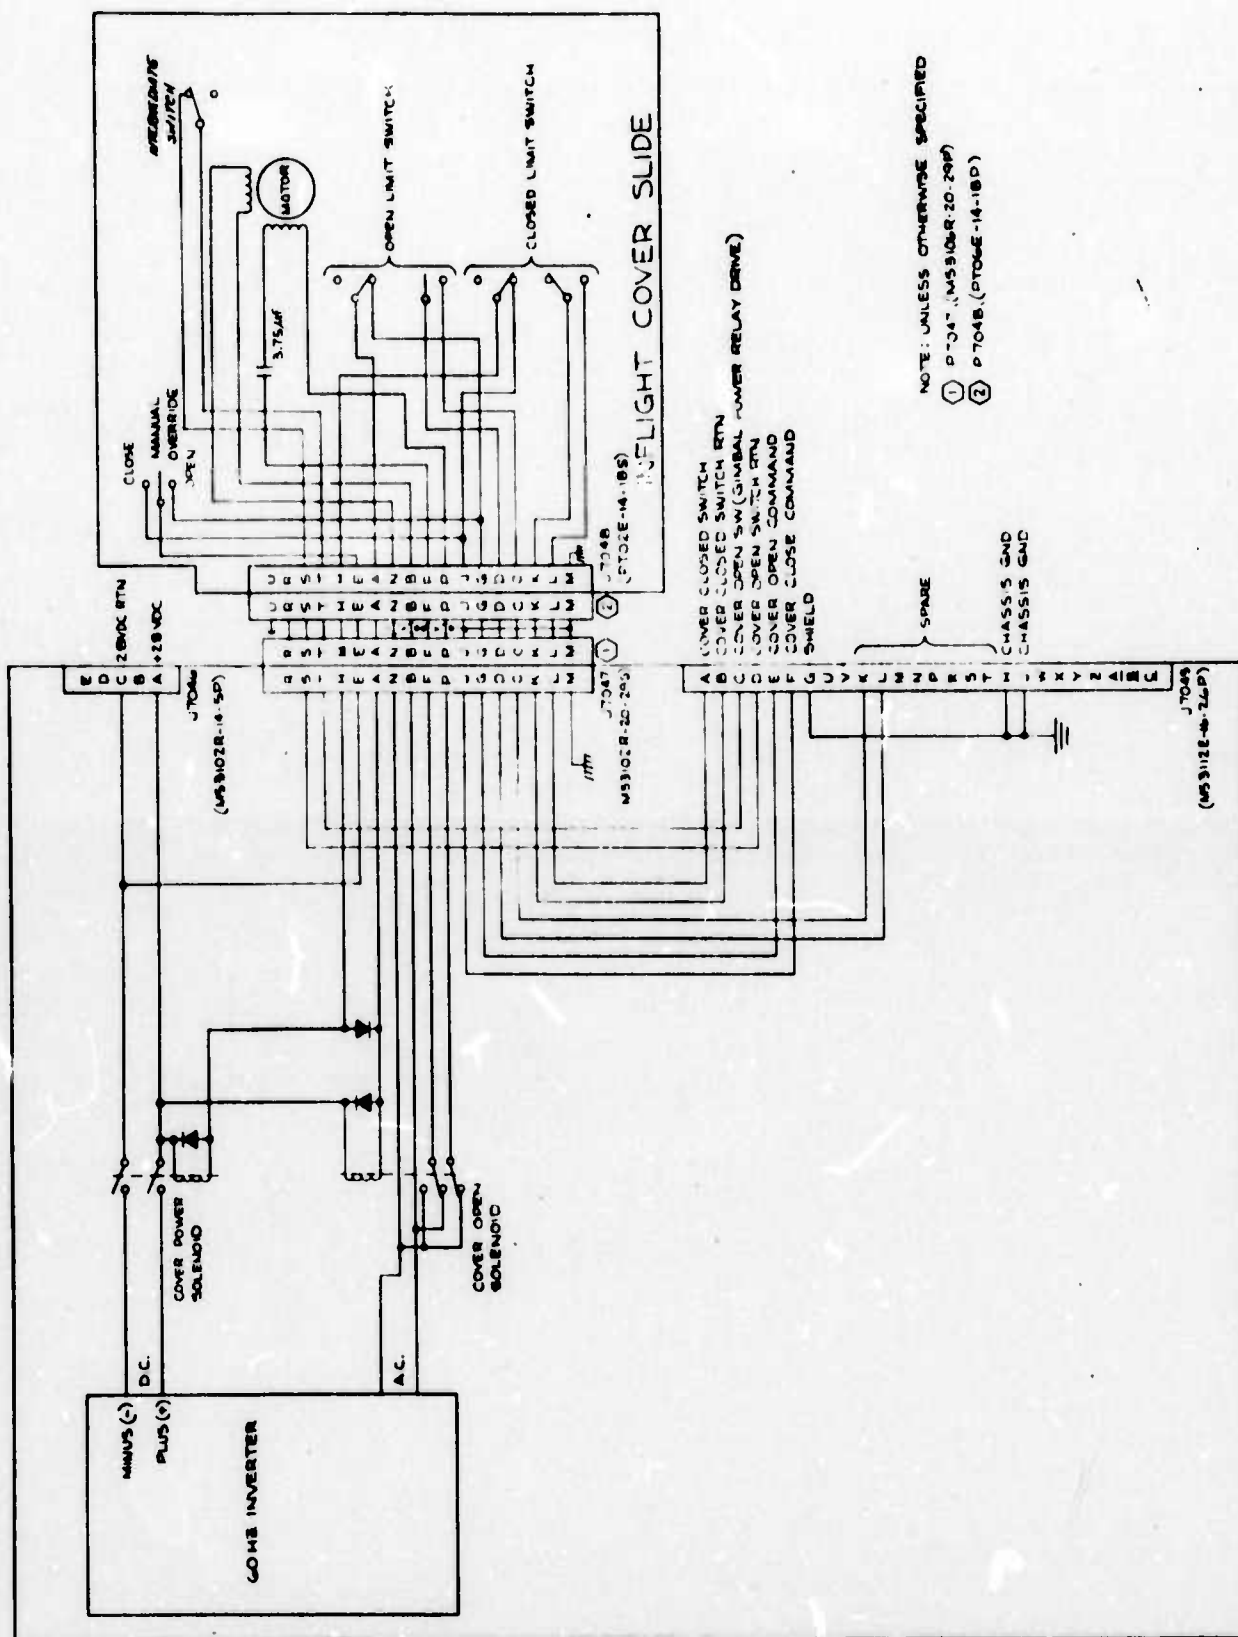
Figure 12-18. (4-2) Schematic of Inflight Cover Assembly

In order to use the cover as an approximate full field in-flight calibrator its surface was anodized and sandblasted and a temperature sensor with a telemetry read-out was installed on it. Its exposed surface was insulated to help maintain a low and uniform temperature. Additional temperature sensors and temperature reporting circuits were provided for the control electronics cannister, the output electronics cannister, and the programmer. A broken connector was repaired on the power distribution box.
